## CHISINAU WATER SUPPLY & SEWAGE TREATMENT - FEASIBILITY STUDY

Contract No: C21156/ECWC-2010-01-01

**Non-Revenue Water Assessment - FINAL**

August 2012

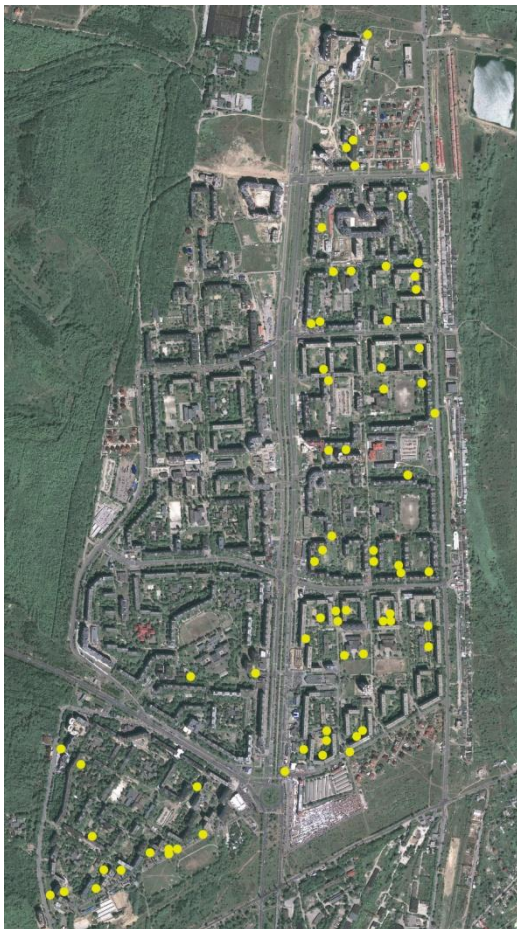
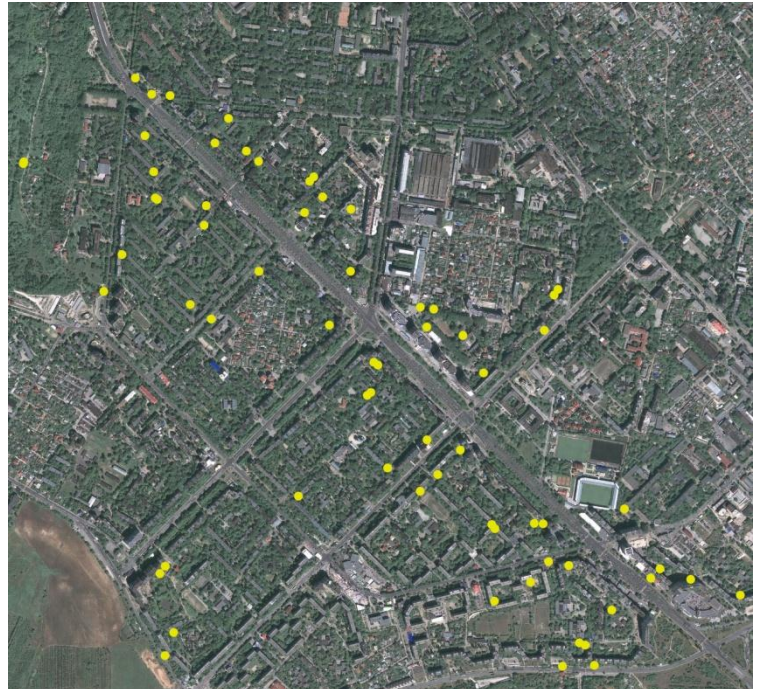
*Figure 9 : Leaks in CIOCANA PZ # 3 & INDEPENDENTA-BOTANICA PZ # 3*

- **CIOCANA (PZ # 3) with 1.7 hidden leaks detected and located per kilometre** (76 leaks over a total inspected length of 46km). The measurement campaign on

These two areas with high levels of losses (7 255 m<sup>3</sup>/day for CIOCANA PZ # 3 and 4 675 m<sup>3</sup>/day for INDEPENDENTA-BOTANICA PZ # 3) can therefore be subject of periodical and intense leak detection and location activities, as they are prone to high operating pressures (6 bars to 8 bars), which added to the structural weakness of the current network, explains the high levels of hidden leaks in these two areas.

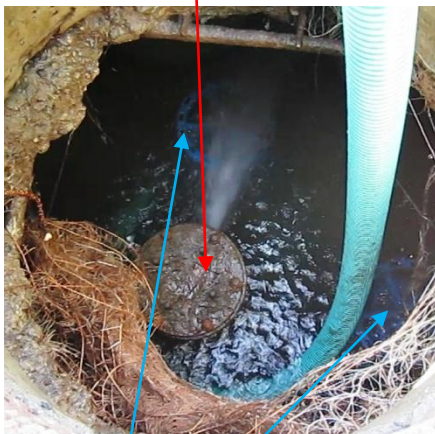
- The percentage of detected and located leaks on valves is very high, even higher when joining the contribution of fire hydrants. Many hydraulic accessories on the water supply network in Chisinau are in bad conditions, timeworn and with high levels of corrosion, which means that a lot of them cannot be operated. Leaks are found on faulty gaskets located next to the flanges or to the stem, but also on empty valves bodies that were sealed with a steel plate.

Old empty valve body sealed with steel plate

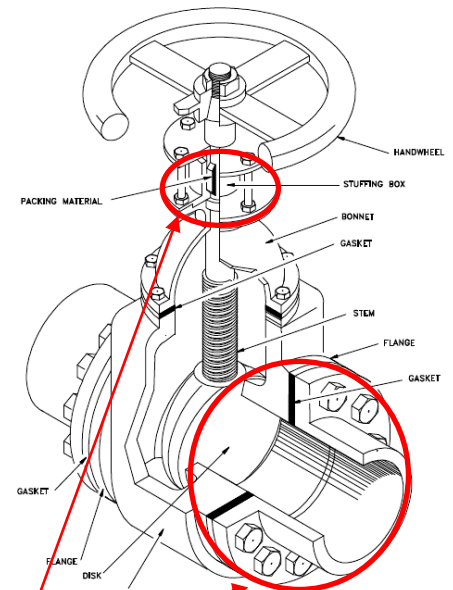
Old valve with faulty gasket next to the stem

- Most leaks on valves (many examples found by the leak detection and location team) are due to a defective stuffing box assembly. The best practice to repair a leak on a stuffing box assembly is to use a permatight seal. The valve stem must be dismantled, and a specific permatight diameter seal put in place.

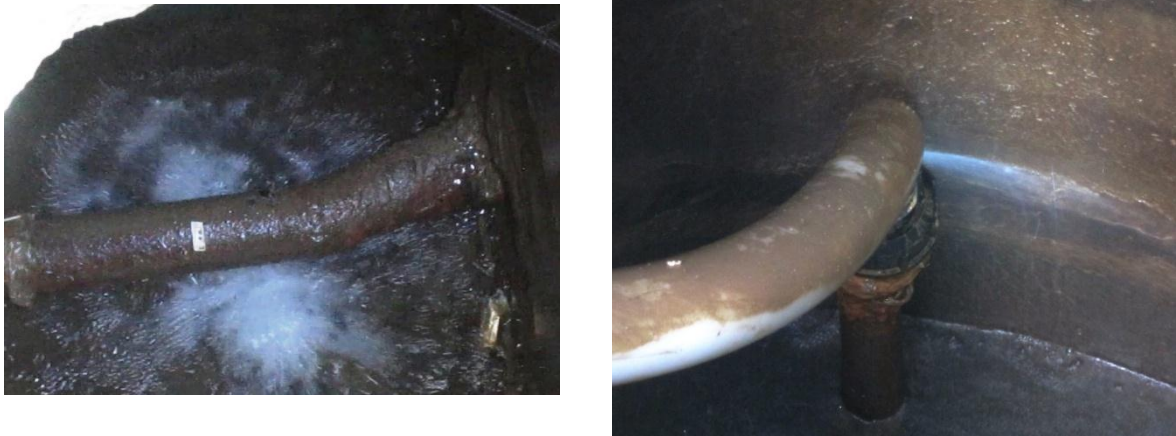
Figure 12 : Typical leaks found on mains & service connections in Chisinau WS network

- The percentage of detected and located leaks on service connections is very low (9% of the total – 17% when excluding hydraulic accessories) when compared to international ratios which generally show that 80% of leaks are repaired on service connections and 20% on water mains. In Chisinau's context, it could be explained by the fact that the leak detection and location team allocated its efforts into highly dense areas, with predominant vertical habitat and a low rate of service connections per kilometre inspected when compared to areas with predominant horizontal habitat.

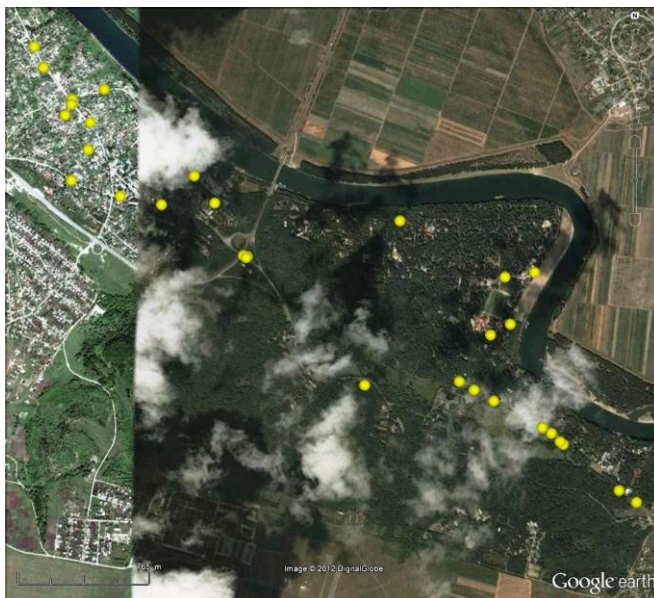
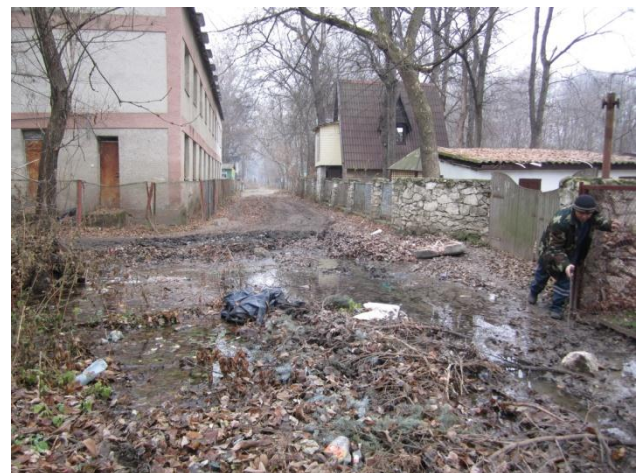
Figure 16 : Leaks in VADUL-LUI-VODA hydraulic entity

The team inspected 85 km on the water supply network, finding 31 leaks, from which:

- 12 were on DN 300 mm pipes (steel and cast iron);
- 3 were on DN 150 mm pipes (steel);
- 4 were on DN 100 mm pipes (steel);

The leaks found in Vadul-lui-Voda urban centre and the forests alongside the Nistru River towards Balabanesti were in their majority large breaks on the transfer and distribution pipes that had created small lagoons in streets and neighbouring fields, without being properly reported to ACC by local customers and network operators. Furthermore, breaks were observed on wastewater collectors, close to the recreational and vocational areas. This means that proper attention should be brought to peripheral communities within the

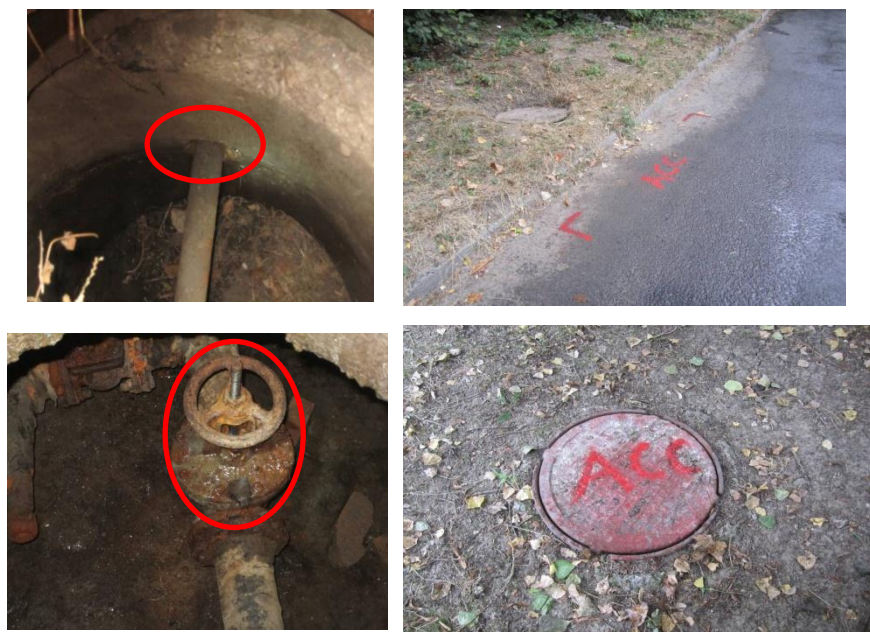
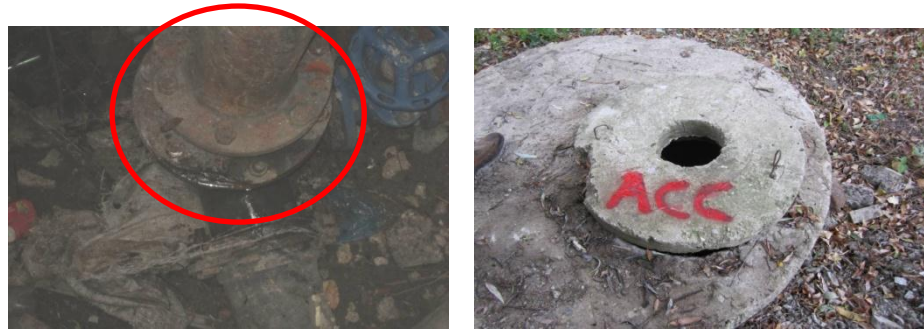
*Figure 17 : Unrepaired leaks reported as solved by operational sectors*

- Leaks that needed trench digging (mobilization of heavy-duty equipment) and road/sidewalk rehabilitation;
- Leaks on accessories (valve gaskets or hydrant flanges) that might have been considered as "too small" to be repaired;

Such situations argue in favour of the implementation of a control procedure that would weekly select a sample of reported repaired leaks for field inspection to determine whether the work was really carried out or not.

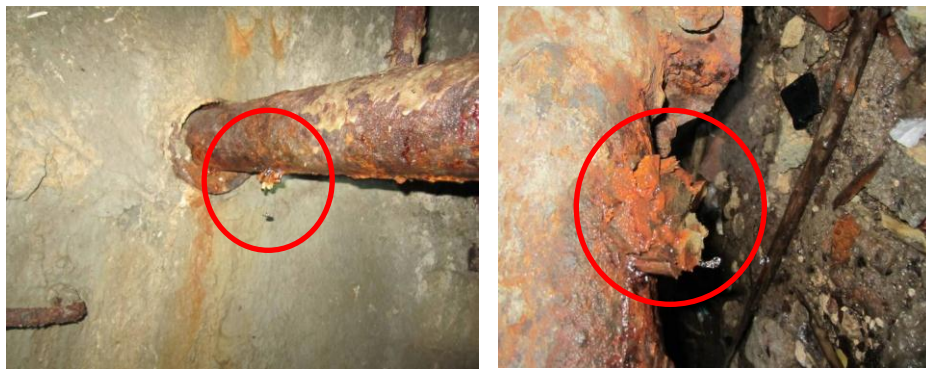
*Figure 18 : Leaks still active after repair*

The control/supervision exercise allowed also finding leaks still active after repair. Indeed, current repair techniques used by ACC's crews are limited and very often cannot effectively restrain the leakage flow (the current leaks' recurrence rate is around 30%).

- Leaks due to corrosion on steel pipes ("hole in pipe" type of failures) are being repaired with wooden cones inserted in the hole with a sealing paste;
- For leaks on large steel pipes, a piece of steel is welded on top of the wooden cones, and normally bitumen is applied on top on the welded plate to protect it from further corrosion;
- Circumferential breaks: this type of failure occurs on cast iron pipes when differential pressure applies on the pipe. The cast iron pipe is very sensible to this phenomenon, and breaks mostly happen at thaw periods. For this type of failure, the repair is done by ACC using a piece of steel pipe cut lengthways in 2 pieces. 2 twisted wires are welded 5 cm from the extremity of each side. The 2 pieces are then welded together around the circumferential break on the cast iron pipe. The tightness is done with some rope mixed with bitumen, and then beating

- For circumferential breaks and corrosion pin-holes in steel pipes: the repair will use of a stainless steel repair clamp;

- For longitudinal splits or any repair where a piece of pipe needs to be replaced (excessively corroded pipe, joint leaks, or an outburst): the repair will require a piece of pipe of the same material (cast iron on a cast iron failure), and 2 couplings large tolerance;

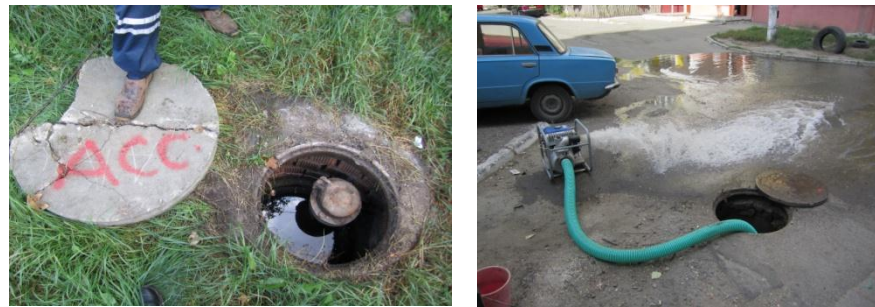
*Figure 22 : Network manholes full of water*

Current manholes used to access the water supply network are often full of water (leakage water or surface/ground water), which prevents the leak detection and location team of using contact points for acoustic correlation or direct listening. The team always had to carry a dewatering pump that turned out to be essential for the works.

ACC should therefore continue with the regular inspection of manholes/chambers on the water supply network, which could be done by a dedicated person in each operation sector in parallel of the proactive leak detection and location activities. Such waterlogged chambers and manholes accelerate the process of corrosion as pipes and hydraulic accessories are permanently immersed in water.
