APA CANAL CHISINAU

CHISINAU WATER SUPPLY & SEWAGE TREATMENT - FEASIBILITY STUDY

NETWORK OPERATION RECOMMENDATIONS - FINAL

August 2012

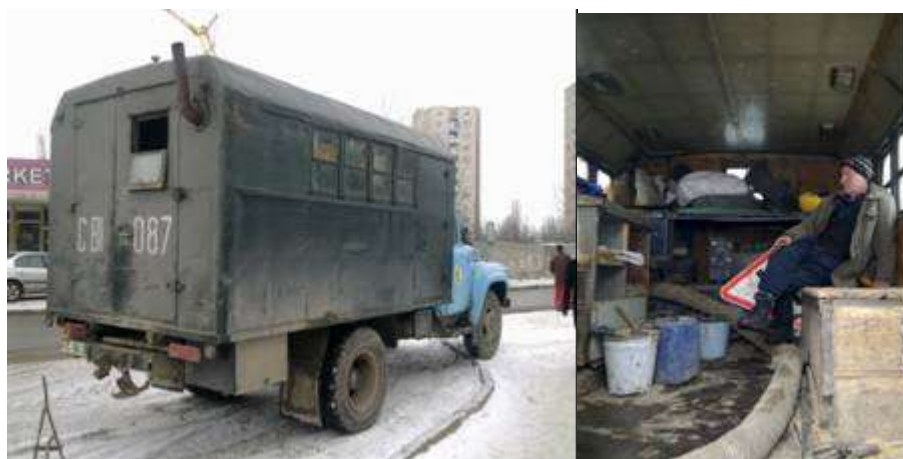
Figure 6: Examples of ACC Truck at Botanica sector (exterior and interior)

The old trucks, equipped with a welding infrastructure, have a very high fuel consumption rate of 40l / 100 km.

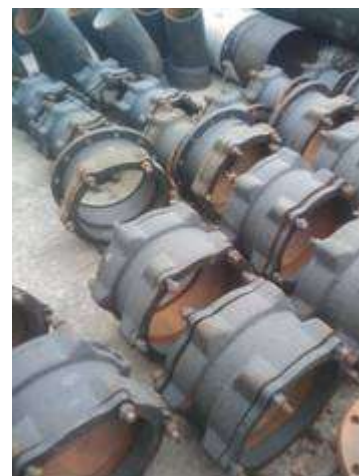
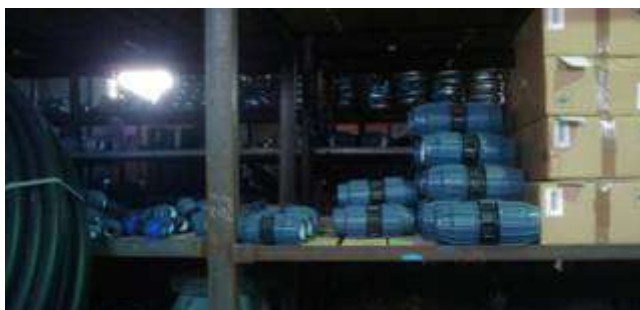
After having visited the Central Store House and the Riscani Sector, we can conclude that no Water Pipe Repair Parts are used within ACC. Only a few pipe coupling for Ø250mm were found in the CSH, and we discovered later from discussion that they are the remaining parts left at the end of a big ductile cast iron pipe work (100 km). But it doesn't seem that they are regularly used.

Only a few Compression PE pipe fittings were found in the Central Storage House

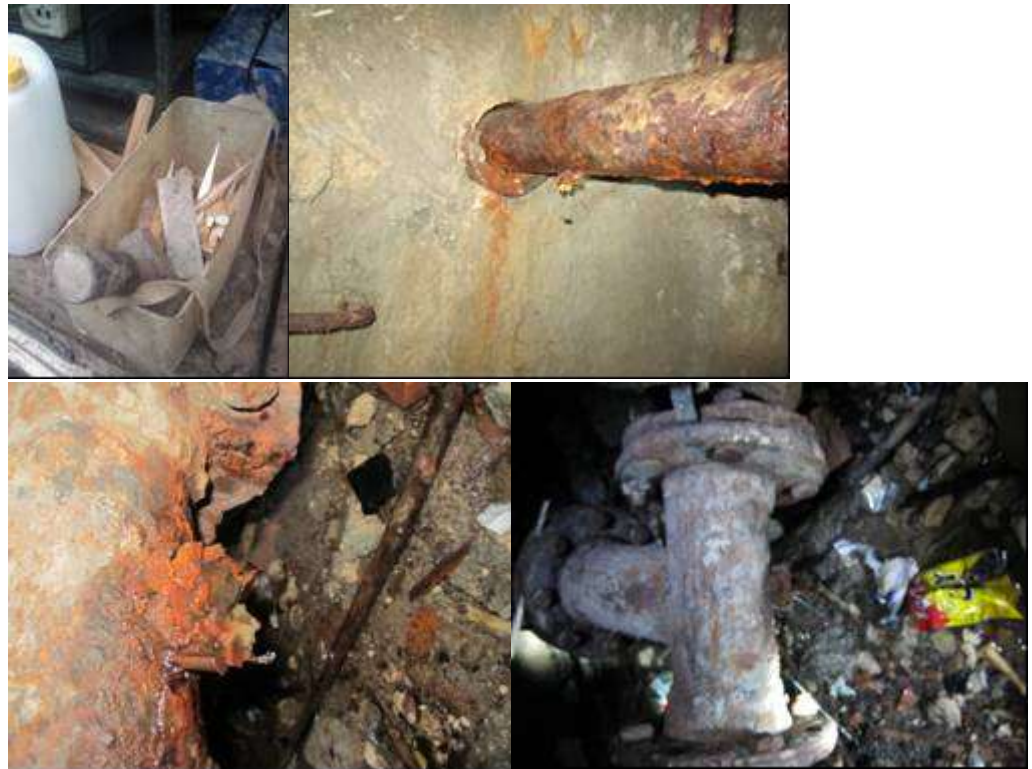
- Leaks due to corrosion on steel pipes ("hole in pipe" type of failure) are being repaired with wooden cones. The 1st of the following pictures shows the wooden

cones prepared for a repair on a Ø500mm Steel Pipe, and the other ones leaks found by SEURECA leak detection campaign on previously repaired holes with wooden cones.

- We have been said that on big steel pipes, a piece of steel is welded on top of the wooden cones, and then that, normally, bitumen is applied on top on the welding to protect it from further corrosion. But we have not witnessed such a practice. Furthermore, and reportedly, it seems that this protection is not always done because of the bad smells for the residents.
- Circumferential breaks: This type of failure occurs on cast iron pipes when differential pressure applies on the pipe. The cast iron pipe is very sensible to this phenomenon, and breaks happen mostly at thaw, but not only. For this type of failure, the repair is done within ACC using a piece of steel pipe cut lengthways in 2 pieces (see photo below). 2 twisted wires are welded 5 cm from the extremity of each side.

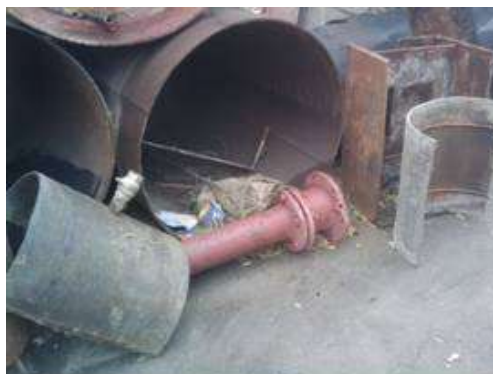
The 2 pieces are then welded together around the circumferential break on the iron cast pipe. The tightness is done with some rope mixed with bitumen, and then beating some lead to finish.

The risk or problem of this technique is that the welding will corrode quickly and a new leak will happen. Problems happen also with the tightness of the lead. We have witnessed such a problem on the leak we inspected on Wednesday 16th November.

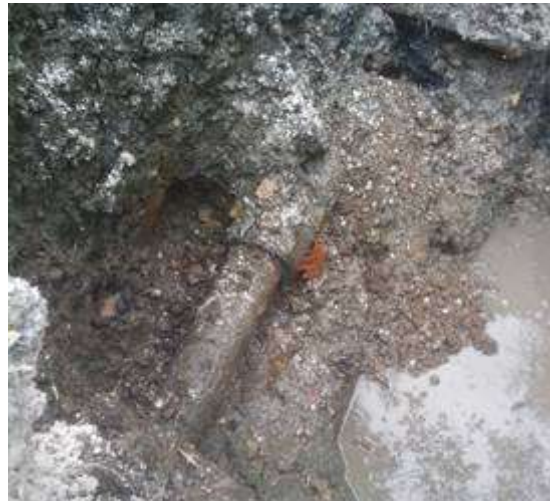
- Longitudinal splits: This type of failure occurs on both cast iron pipes and steel pipes in case of high pressure. For this failure, and any other type which requires the replacement of a portion of the pipe, the repair is done within ACC using a piece of steel pipe with 2 couplings made as described above (with a piece of steel pipe cut lengthways in 2 pieces and then welded together around the pipe to link). Again, this type of repair, with the corrosion of welding, will lead to further failures.

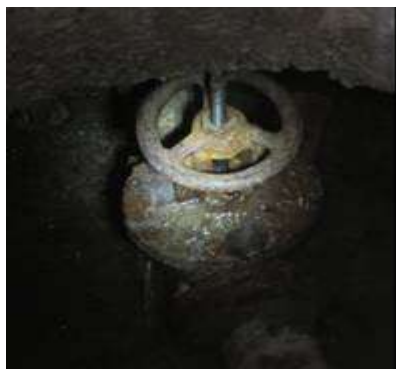
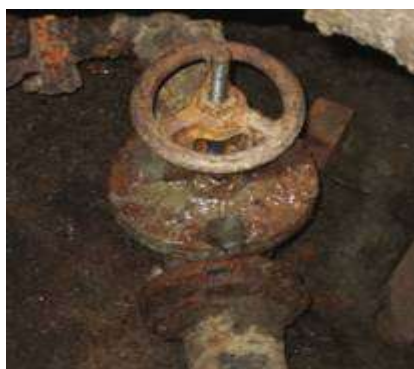
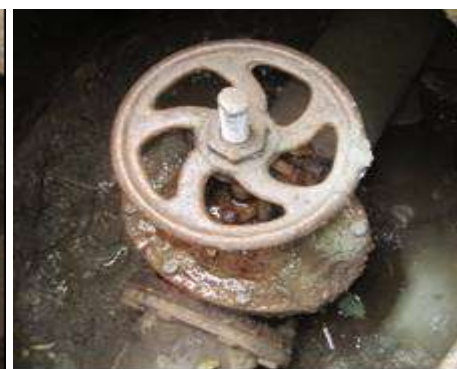
Most leaks on valves (many examples found by the leak detection team) are due to defective “stuffing box assembly”.

We haven't seen during our visits any specific repair parts for this type of failure.

The best practice to repair a leak on a stuffing box assembly is to use a “permatight” seal.

The valve stem must be dismantled, and a specific permatight diameter seal put in place.

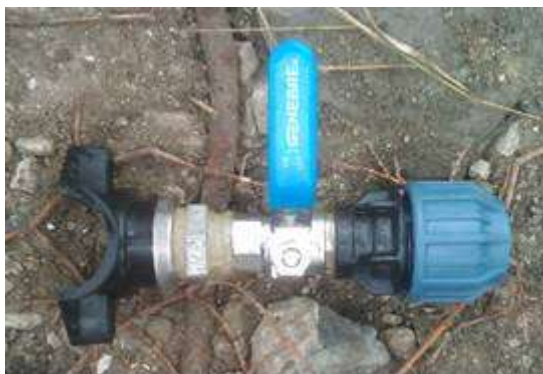
During the visit of the Service Line Division work, we inspected the material used for new connections.

There was no indication of pressure on the collars and they seem to be parts for irrigation rather than for drinking water network

We recommend to use a all-in-one solution adaptable for several diameters

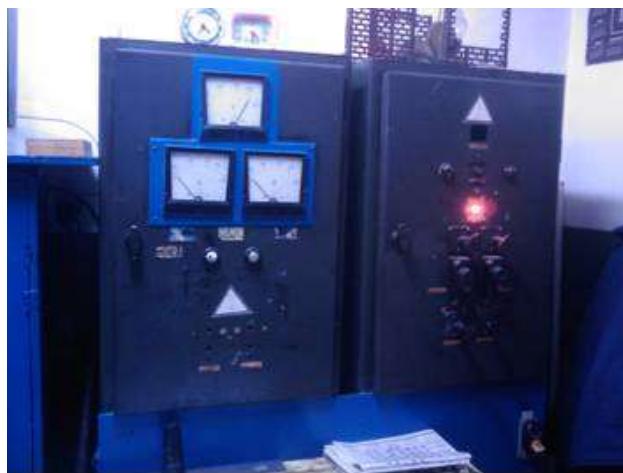
The electrical panel on the 16 old pumping station not rehabilitated are effectively quite old, but indeed quite basic and easy to maintain.
