## CHISINAU WATER SUPPLY & SEWAGE TREATMENT - FEASIBILITY STUDY

Contract No: C21156/ECWC-2010-01-01

**Non-Revenue Water Assessment - FINAL**

August 2012

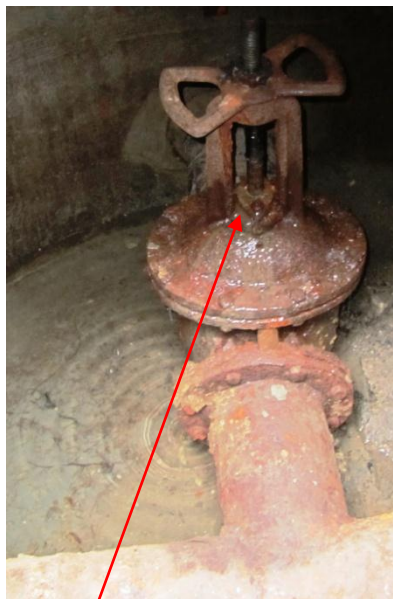
Old valve with faulty gasket next to the stem

- Most leaks on valves (many examples found by the leak detection and location team) are due to a defective stuffing box assembly. The best practice to repair a leak on a stuffing box assembly is to use a permatight seal. The valve stem must be dismantled, and a specific permatight diameter seal put in place.
